**Use of PE 100 supply pipes for the new construction
of the BMW car factory in Leipzig**

Michael Müller-Ruff, graduate engineer, BMW Group, Munich
Thomas Frank, graduate engineer, BMW Group, Mörfelden

**Wiesbadener Kunststoffrohrtage 2004
28 and 29 April 2004**

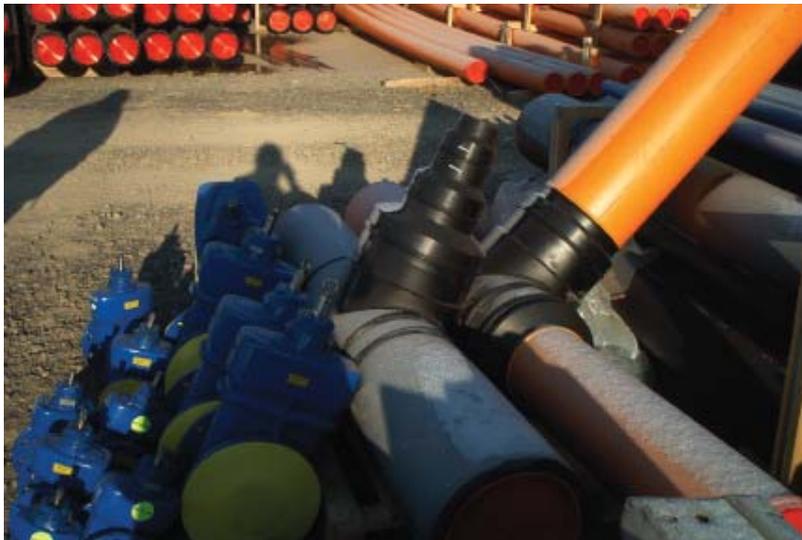
To optimise construction site workflows, a large number of the parts were already pre-assembled at the factory (Photo 1).

Photo 1: pre-assembled branches for gas pipes and fire mains

The pipes and moulded parts were connected by means of thermo-compression butt welding (mainly in the larger dimensions) or through electro fusion welding (small dimensions and connections in cramped spaces).

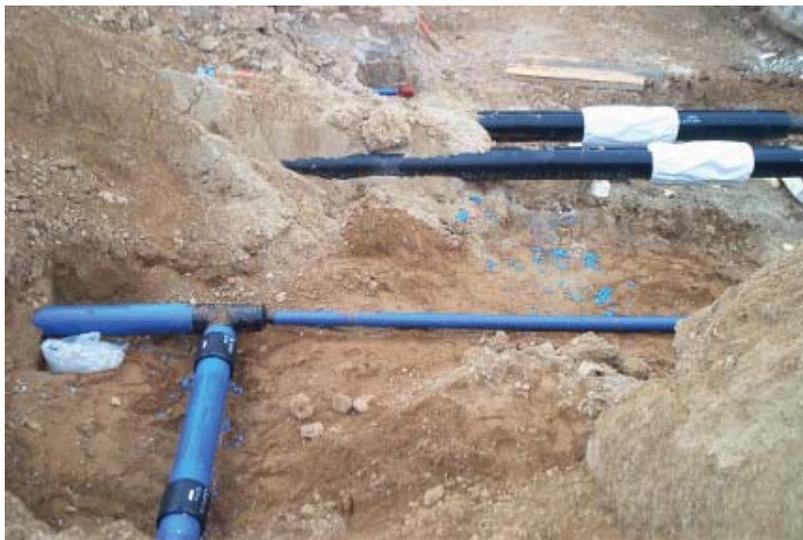
Because BMW's experience with compressed air pipes made of PE 100 was also favourable in the past, the entire earth-laid part of the compressed air network was constructed with the Agruair-System made of PE 100 (Photo 2).

Photo 2: Agruair compressed air pipe and fire main (background)

This pipe system was predominantly connected by means of electro fusion welding due to the smaller dimensions to be welded.

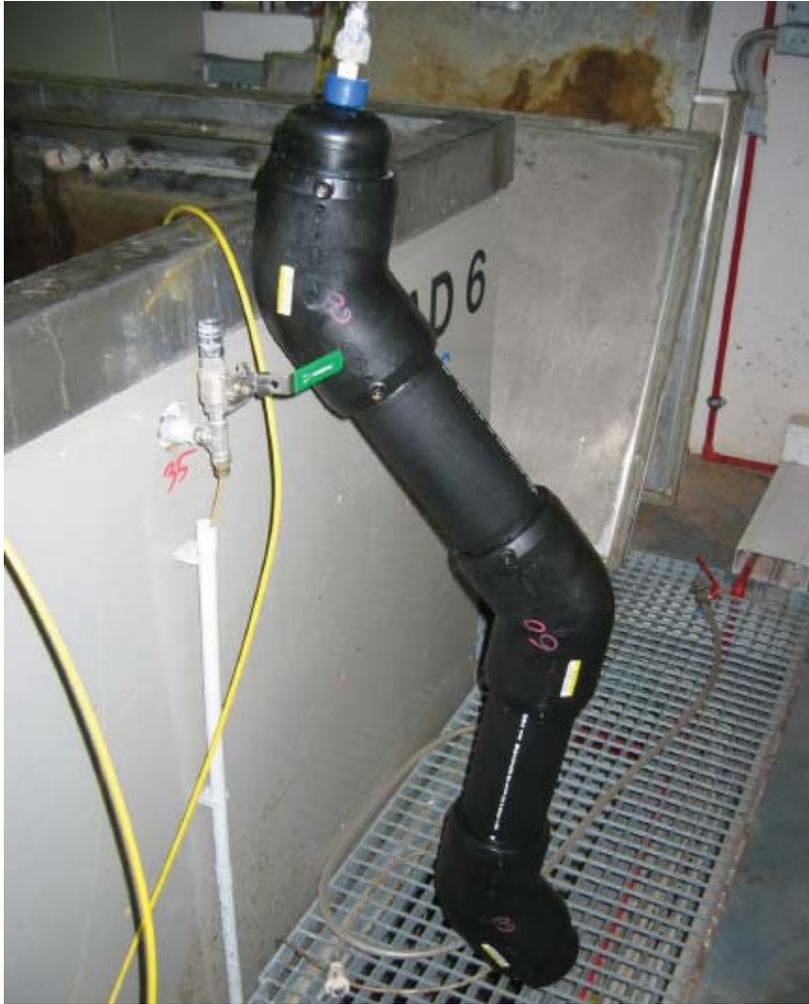
However, the greatest demands on the pipes and moulded parts are made by the prescribed internal pressure creep rupture tests (Photo 4).

Photo 4: Internal (burst) pressure test at a testing stand in accordance with FM standard 1610

These tests must be carried out in two phases every 8 hours. During the first step the components are pressurised with double operating pressure for 5 minutes. There must not be any leaks or permanent deformations during this phase. Then the pressure is increased to the fourfold operating pressure during the second phase. It must be possible to maintain this pressure for 5 minutes as well. Deformations and small leaks are admissible, but leaks that lead to a pressure drop or failure of the components themselves mean that the test was not passed.

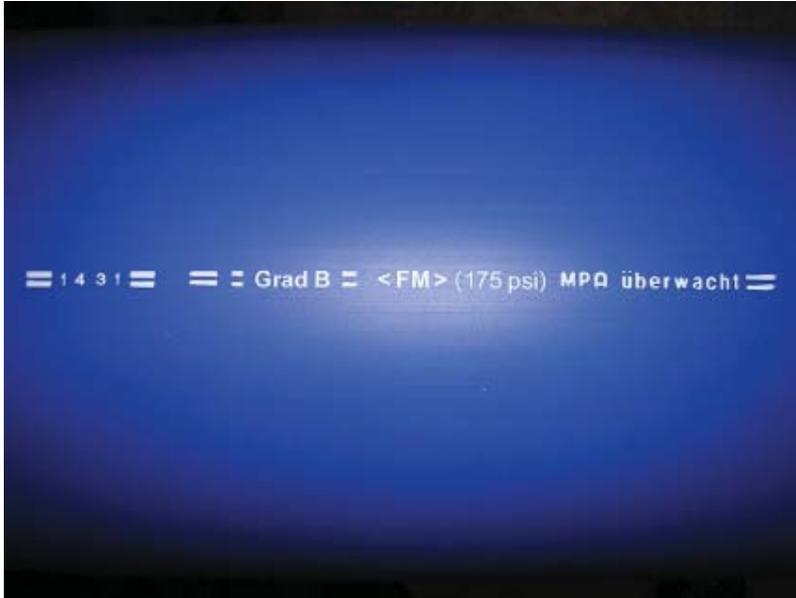
These tests must be carried out on all parts – e.g. also flange joints. Because the inspection effort connected with this is enormous, these tests are carried out to order in normal cases. Parts that were tested in accordance with the approval criteria are specially marked at the factory for these reasons (Photo 5).

Photo 5: Marking in accordance with FM standard 1610

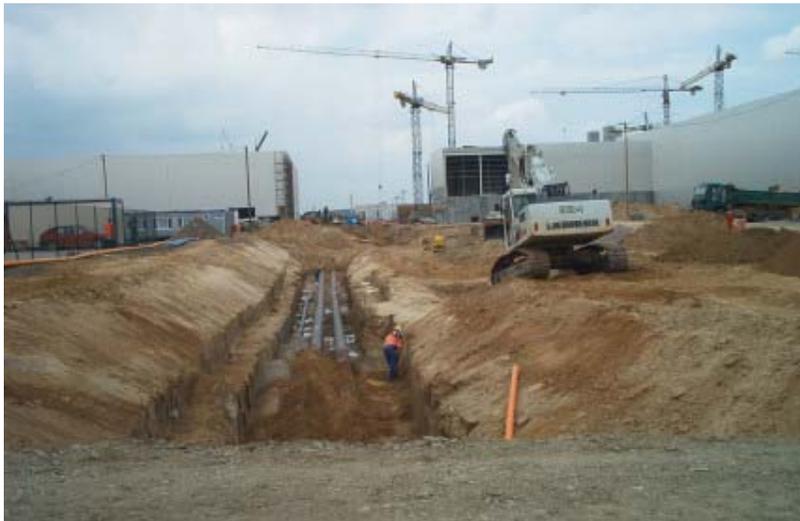
Photo 6: Parallel connecting pipeline to a sprinkler sub-central room

The installation of the supply pipes was largely completed by spring 2003 (Photos 6 to 9). The moulded parts used in the main pipe were constructed with short weld-on ends due to the dimension. Fittings (cast iron) were connected exactly like the adapters in the sprinkler sub-central room with flange joints.

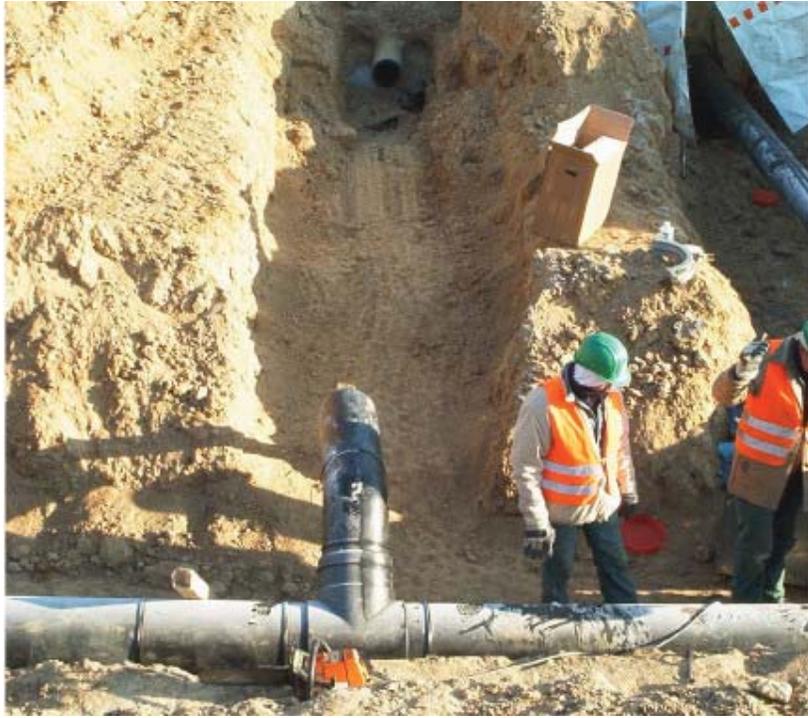
Photo 7: Branch from the main pipeline (DN 300) to the sprinkler sub-central room (DN 250)

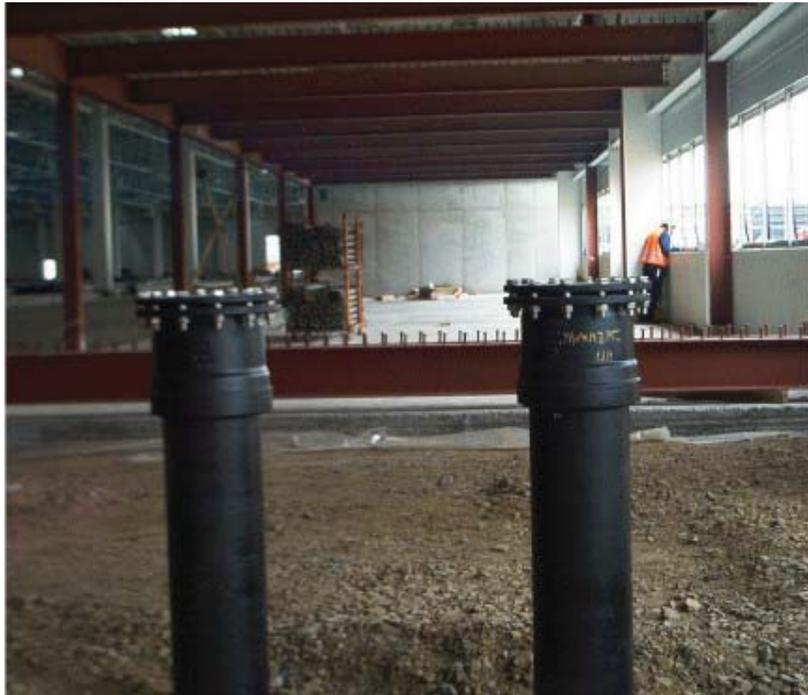
Photo 8: Prepared connection to the sprinkler sub-central room

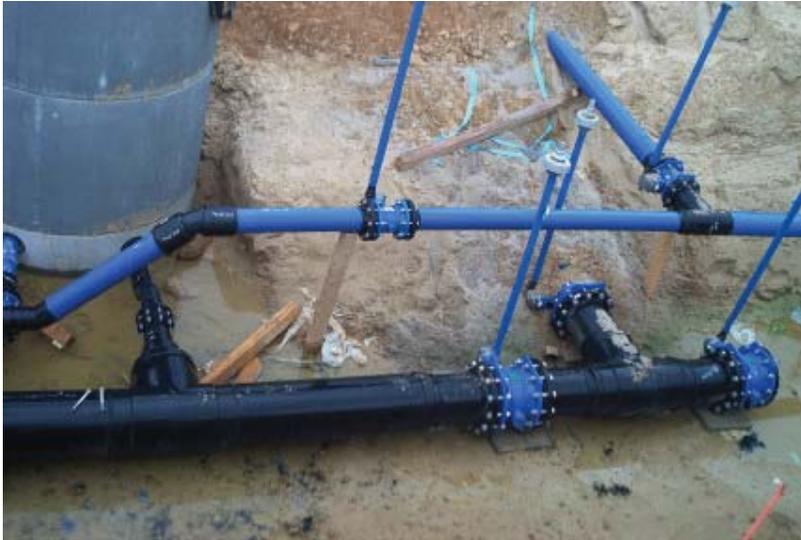
Photo 9: Fittings being fixed in the fire main and drinking water pipe
